One common type of access to the attic that can cause higher monthly bills is the pull-down attic stairs.

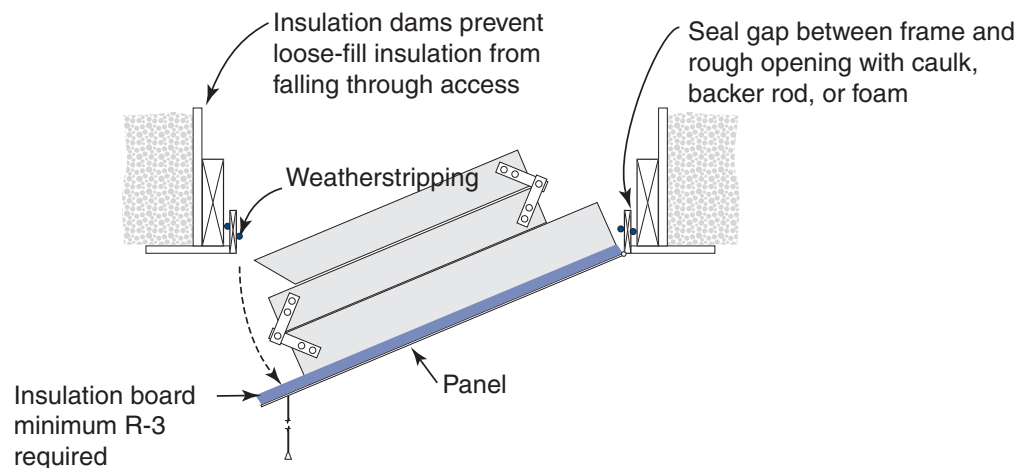
Finally, it's extremely important to add a light-weight attic stair cover box made from rigid insulation above the top of the stairs. The box rests above the stairs on the attic side. The box is simply pushed aside to gain attic access. For details on constructing this box, see the illustration on back.

The frame for the pull-down stairs fits into a rough opening and rests upon a flat panel that is on the living-space side.

To ensure a tight fit, add weather-stripping where the flat panel fits against the ceiling. Adding a latch bolt on the living space side ensures a tighter seal.
